Insight into the traditional timber frame walls: Herculaneum evidence versus braced frame structures in Portugal and in Italy

Stefania Stellacci¹

Keywords: traditional timber frame wall, brace timber frame heritage, Herculaneum

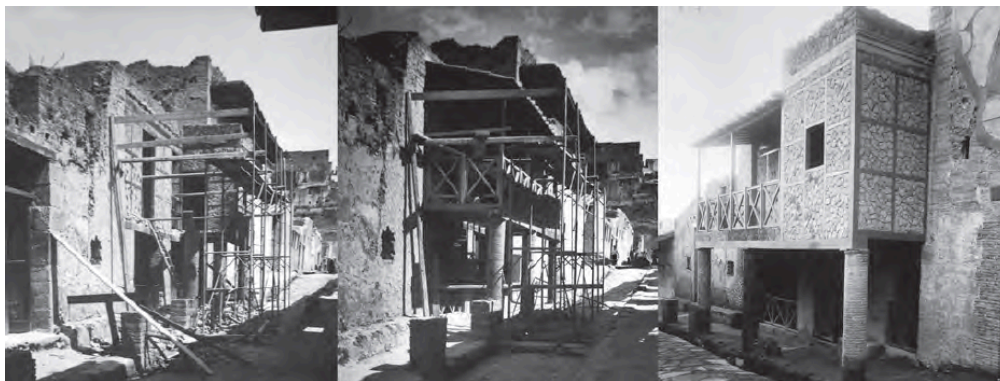
Figure 1: Reconstruction works of *Casa a Graticcio* (1929) [8]

In this paper, a brief analysis of the timber frame walls at Herculaneum is carried out based on literature review and on-site analysis. Firstly, the reasons for the relevant presence of wooden components and the difficulties in gathering evidence are underlined. A remarkable case study, *Casa a Graticcio*, is described as precious yet controversial physical evidence. Its speculative reconstruction, often overlooked in the literature, is discussed to raise issues related to its value, conservation, and public appreciation (Figure 1).

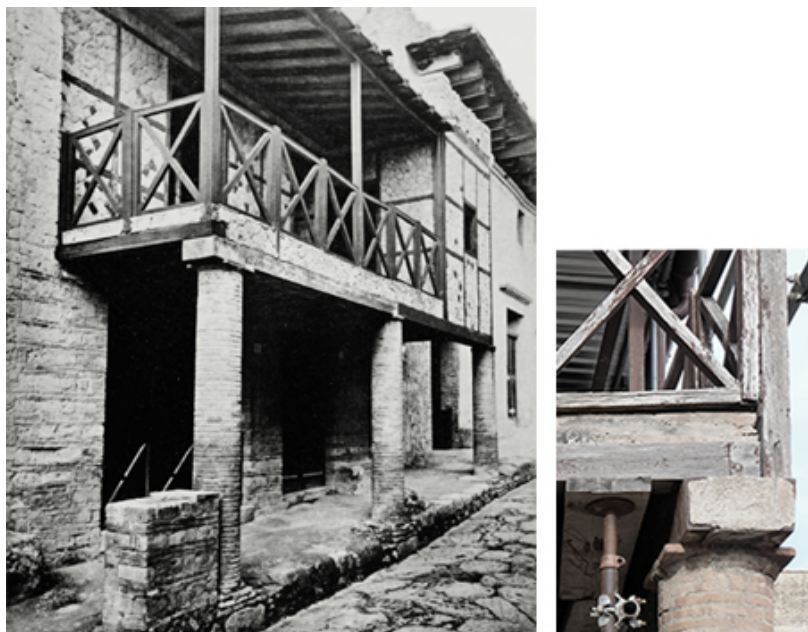
As occurs in other buildings at Herculaneum, the type and the regularity of the replaced elements expose the modernity of this intervention that aimed at a semantic unity. In addition, the high degradation of the materials induced by these improper and incompatible restoration works is clear evidence of the low authenticity of this building following its reconstruction. On the external facade, the detachment of the coating layer shows two L-shaped steel beams distanced by hollow bricks that support the balcony and bear on the aforementioned pillars (Figure 3). The square frames of the external upper walls, whose timber components were replaced by new elements of the same size, were filled by blocks of yellow tuff stone [16], which is a foreign material to the local construction culture.

Figure 3: *Casa a Graticcio* (Insula III, 13-15, Herculaneum): main elevation after the 1930s restoration [16] and detail of L-shaped steel beams (2016, photo by the author).

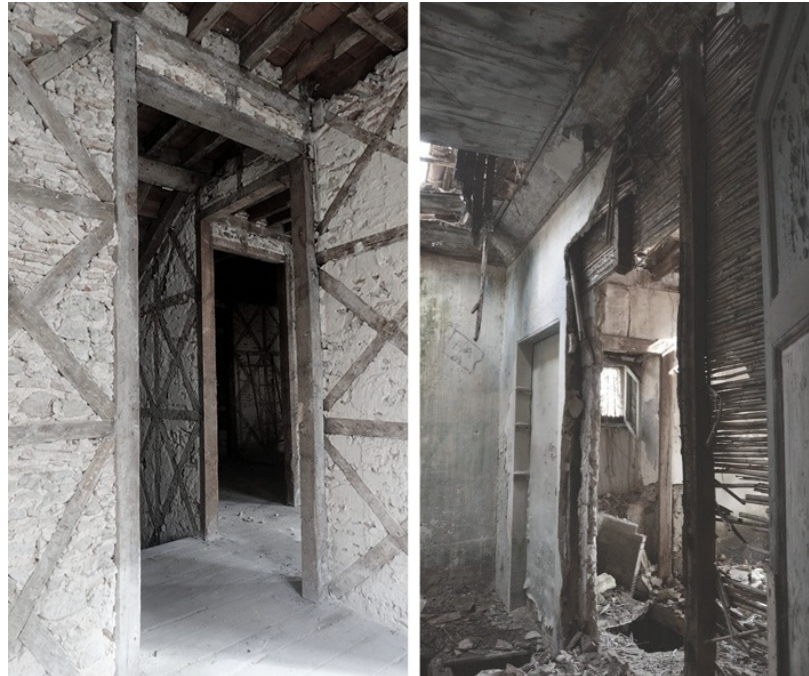
In contrast to the uniformity and standardization of the *Pombalino* system, several construction layouts and geometrical can be found in the braced frame heritage of the South of Italy. In these buildings, the timbered walls are filled in rubble masonry (external walls) or with horizontally arranged reeds between regularly spaced vertical posts (internal walls), as shown in Figure 5 [10]. As proven by recent experimental campaign, the timber framework would provide to the masonry wall an additional tensile strength under dynamic action [18].

Figure 4: Internal timber frame wall: *Pombalino* building in Lisbon versus Bishop's Palace in Mileto (Calabria region) (2015, photo by author).

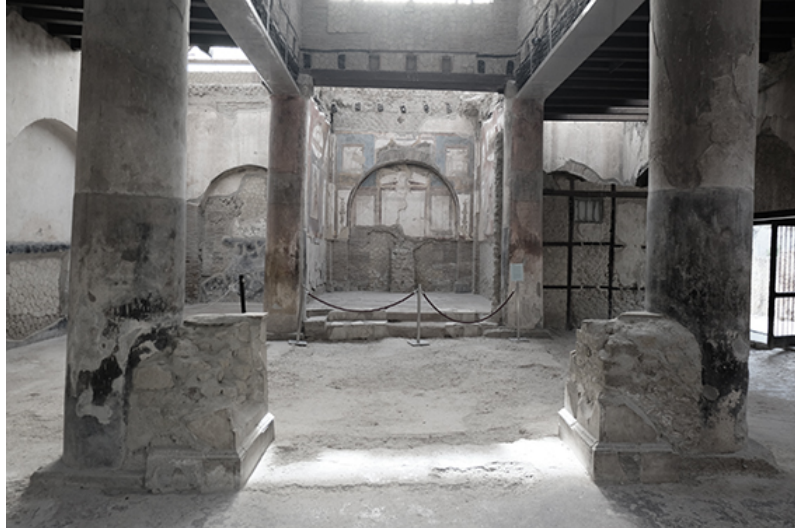
In *Pombalino* buildings, a vast number of timber elements are lumped together by iron or metal ties [9,10]. The most common carpentry joints are half-lap joints (cogged half-lap joint or dovetailed or wedged dovetail) and mortise-tenon joints. These joints together to the *Trait de Jupiter* can be found also in the Herculaneum findings.

Figure 5: *Collegio degli Augustali*, Herculaneum (2016, photo by author).
