## PHOTOGRAMMETRY: METHODS OF SURVEY AND APPLICATIONS ON RESTORATION WORKS

Soraya M. Genin

### ABSTRACT:

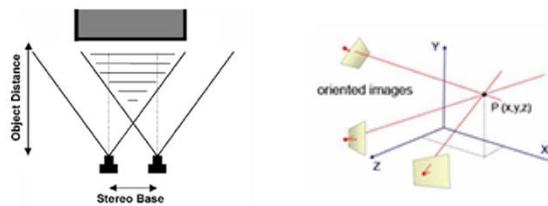
Figure 1. Two methods for obtaining three-dimensional models: stereophotogrammetry with parallel photographs (left) and photogrammetry of multiple images, with convergent photos (right) (Bastian, 2013).

The article presents different methods of Digital Terrestrial Photogrammetry applied on Conservation projects and works: single-image photogrammetry (or 2D photogrammetry); stereophotogrammetry (two images obtained with parallel axes to each other); Photogrammetry of multiple images (convergence or monoscopic photogrammetry) (Mateus, 2012). To obtain 3D model, the two last methods are possible (Figure 1).

The chosen method of survey was the stereophotogrammetry, a technique based on the use of two photographs of the same object, whose optical axes of the cameras are parallel to each other and the images have the same direction and distance to the object. From a photogrammetric pair it is possible to draw the object (figure 1a).

The photogrammetry with convergent photographs (figure 1b) was tested for the vaults, but stereophotogrammetry was advantageous because it allowed better observation of the vault joints. For the restitution, it is necessary to observe the same object in two photographs, which was not the case with converging photographs, due to the presence of the ribs.

In this survey it was used the method of multiple-image photogrammetry (Figure 1b), which is based on the principle of triangulation, the intersection of convergent lines in space and the mathematical determination of the position of a point. The determination of this point consists in the orientation of the images to a coordinate system (x, y, z), being necessary to know, at the time of capture, the coordinates of the point, at least two images, or preferably three or more images (Bastian, 2013).

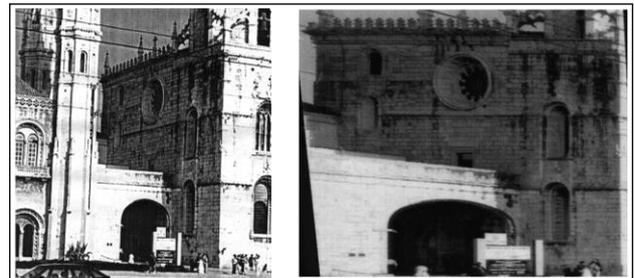
Figure 2 shows the photograph taken (left image) and the rectified image (right image), where it is possible to verify the distortion of the elements that are not in the plane of the facade. Thus, it is only possible to draw the elements of the rectified plane.

Figura 2. West facade of the church of the monastery of Jerónimos, in Lisbon. Single image photogrammetry (Genin, 1995)

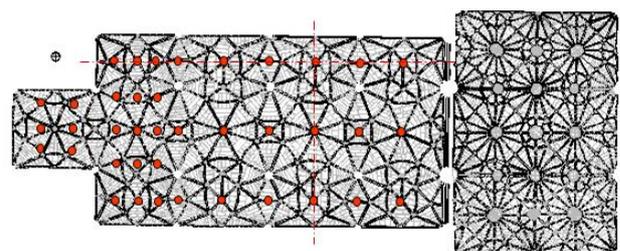
Figure 3. Photogrammetry of the vaults of the church of Jerónimos monastery in Lisbon. (nave and transept). Location of the photos taken in the nave (Genin, 1995).

For the photographic survey of the nave's vault, a total of 45 photographs were necessary, 24 in the first three bays and 21 in the choir. Although the choir has a smaller area, the fact that it is closer implies a greater number of photographs. For the topographic survey, five points were recorded for each photogrammetric model (composed of two photographs), which is the number recommended for the photogrammetric pair.

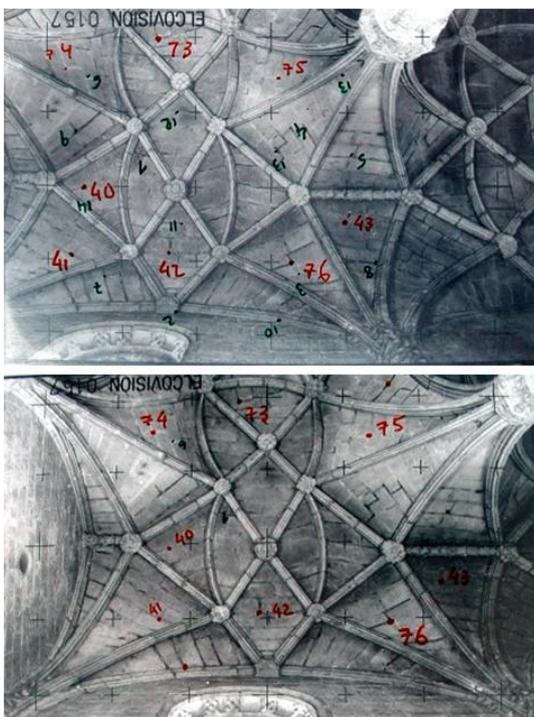
Figure 4. The nave vault of the church of Jerónimos monastery. A photogrammetric pair, with indication of the topographic control points (in red) (Genin, 1995).

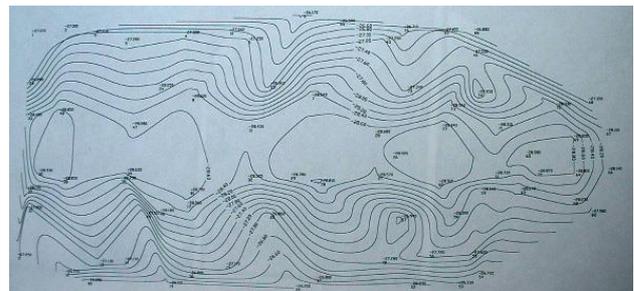
Figura 5. Plan with level curves of the nave vault of the church of Jerónimos monastery (Genin, 1995).

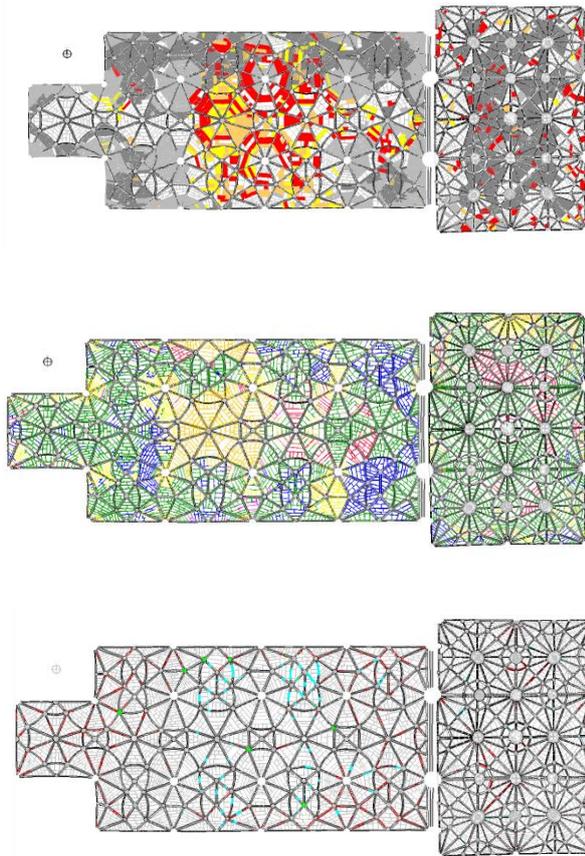
Figure 6. Mapping of the materials and anomalies of the nave vault of Jerónimos monastery: colours of the stones (a) and the joint mortars (b), and pathology of the ribs (c) (Genin, 1999).

The detailed photogrammetric restitution, with indication of all the joints, permitted the registration of all the materials and anomalies observed. Data were collected about the colour of the stones, the colour of the joints mortars, and also about the decay of the ribs (figure 6).

Several types of limestone were found, the liós used mainly for the ribs, and the Encarnadão and the Amarelo de Negrals, to fill the webs of the vault, more incident in the two central bays. Damp spots were visible on the north side of the nave and the central part of the transept.

The joints were filled with various types of mortar, light-colored lime mortars, and rather dark Portland cement mortar. The light mortars again coincided with the two central bays of the nave vault.

The observation of the ribs confirmed several interventions of the years 1927-30, being clearly identifiable lacunae and replacements by new stone. Some ribs showed erosion. The lacunae corresponded to replacements for new stone, as indicated in the archival documents, concerning the intervention.

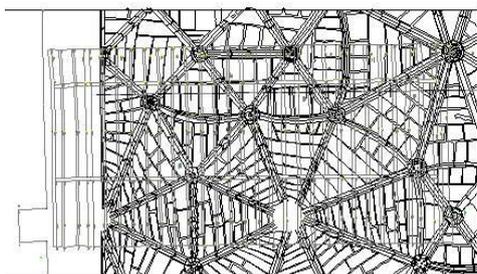
Figure 7. Plan with superposition of the intradors and extradors of the vault of the nave (Genin, 2002a).

Finally, the photogrammetry allowed to develop a series of diagnoses from the extrados of the vaults. After the topographic survey of the extrados, the plan was overlapped with that of the intrados. This enabled great precision in the execution of non-intrusive diagnostic. It was used the metal detector and the georadar. This equipment allowed the obtaining of important data, such as the thickness of the voussoirs and the location of the filling masonry of the haunches.

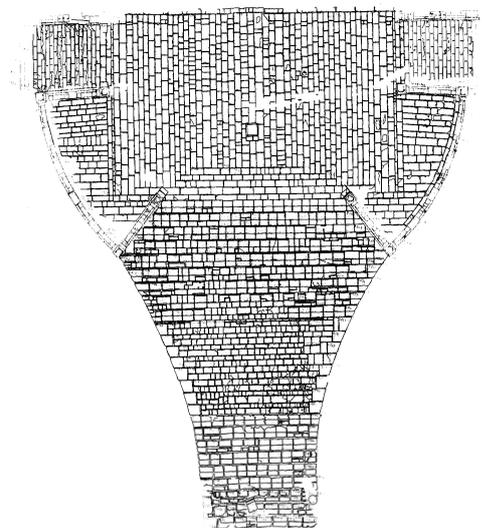
Figure 8. Photogrammetry of the Cais das Colunas, Lisbon. General restitution made during the dismantling (Genin, 1997).

It is worth mentioning another advantage of photogrammetry. The cabinet work can take place in several phases. In this case, all the joints were first drawn, in order to number and identify the limits of each block to be removed, a plan used during the work. After the dismantling, the restitution was more detailed, with all the constructive and decorative details of the stoneworks (figure 9).

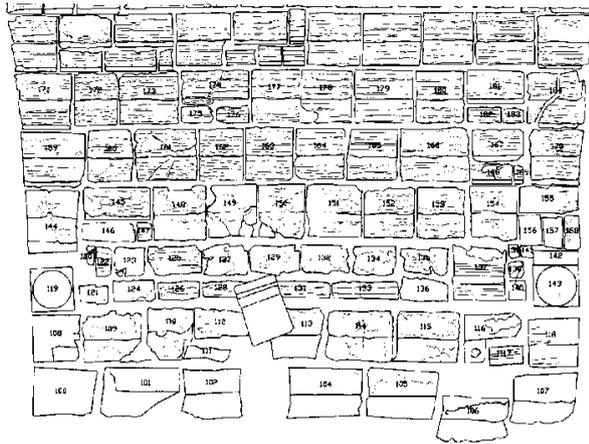
Figure 9. Photogrammetry of the Cais das Colunas, Lisbon  
Detailed restitution made after the dismantling (Genin, 1997).

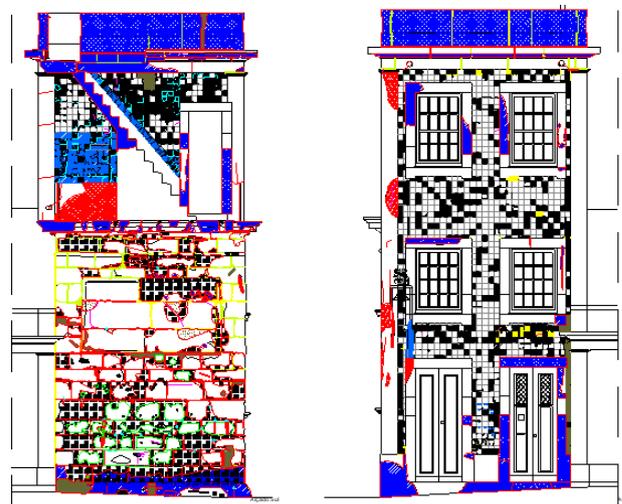
Figure 10. Facades of the São Miguel – o – Anjo lighthouse, in Porto. Mapping of the materials and anomalies, based on the photogrammetric survey (Genin, 2002b).

Thus, a criterion was defined for the registration and mapping of materials and anomalies, based on different hatch patterns and colours.

- Hatch patterns: The forms of alteration have the same hatch pattern for any type of material; the information on mortars and joints are represented with solid colors;

- Significance of the colours: i) Red: superficial and structural alterations (lacunae, plaque, peeling, exfoliation, erosion, holes, fissures and fractures); (ii) Blue: chromatic changes and external elements to the material (black crust, biological colonisation, stain, chromatic alteration, surface deposits); (iii) Green: additional information (other materials: cement mortars), or historical notes (restorations, tiles of the same or extra standard, polychrome, etc); iv) Yellow: given the small size of the tiles and the difficulty of reading the map, in the cases of overlapping anomalies, it was chosen to introduce the yellow, to represent information about the tile (the red represents changes of the glaze, which are superficial).

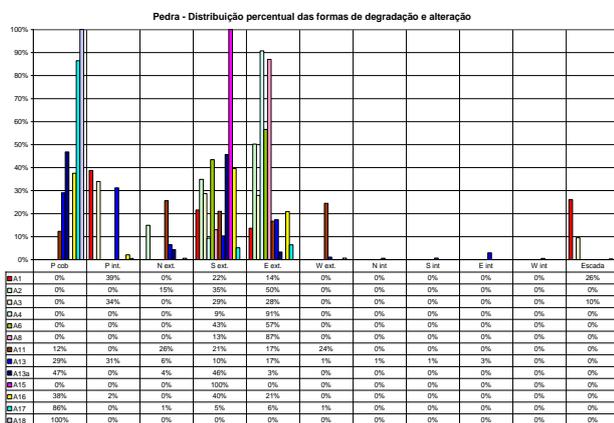
Figure 12. Percentage distribution of forms of decay and alteration (Genin, 2002b).

- Percentage distribution of forms of decay and alteration. In this graph 100% of the observed anomaly is considered and its distribution is analysed in each plan or elevation; it is possible to know, for example, where a particular anomaly is more incident;

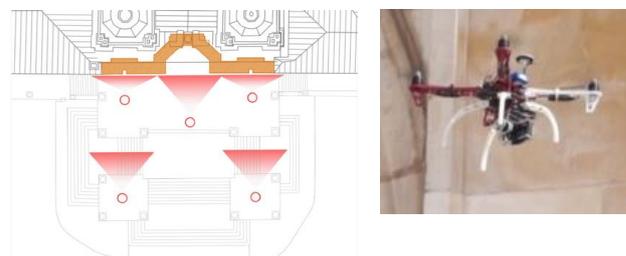
Figure 13. Drone used and location of the five flight stations for photographic survey of the facade of the monastery of Alcobaça (Coelho, Genin, 2016)

For the photographic survey, a total of fifteen flights were carried out from five pre-defined stations: three stations at a distance of approximately 3,00m and 6,00m from the facade, and two stations at 12,00m apart, for photographs of general framework. From each station, the drone performed three vertical flights, capturing convergent photographs (parallel and oblique to the facade) to obtain images with overlapping homologous points (Figure 13).

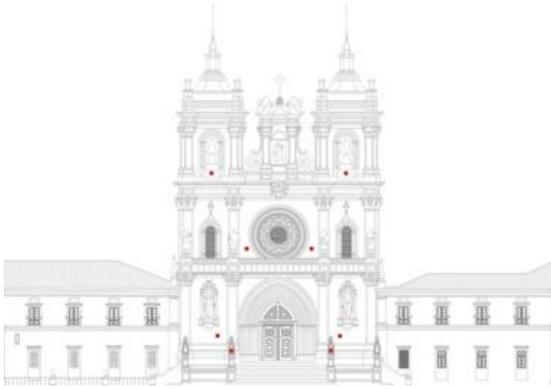
Figure 14. Location of the five control points for the photogrammetric survey of the facade of the monastery of Alcobaça (Coelho, Genin, 2016).

A set of eight topographic control points were located in a dispersed form on the facade, easily identifiable (Figure 14). The topographic survey was developed by DGPC

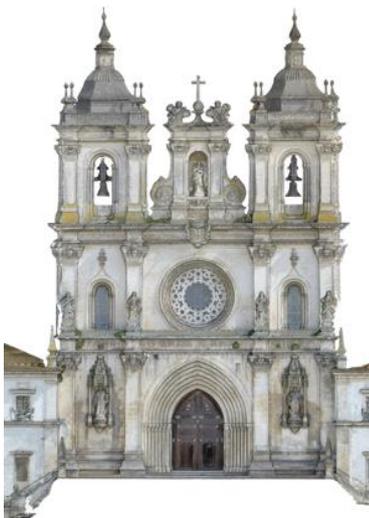
Figure 15. Dense cloud-point reconstruction of the facade of the church of Alcobaça monastery (Coelho, Genin, 2016).

The dense cloud-point reconstruction of the model produced by Visual FM presented several gaps, while the model produced by Agisoft PhotoScan presented a greater number of points, which allowed a better visualisation of the model and observation of details.

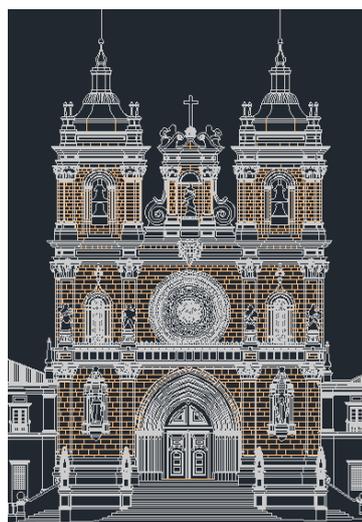
Figure 16. Photogrammetric restitution of the facade of the church of Alcobaça monastery (Coelho, Genin, 2016).

It was used the best definition model for ortho-image and vectorisation production. All visible joints were drawn over the ortho-image. Some joints and anomalies were not identified, mainly due to the high incidence of light on the facade, at the moment of the survey.
