SIZ**A**TLAS

BOA NOVA TEA
HOUSE AND
RESTAURANT

HISTORY AND DESCRIPTION

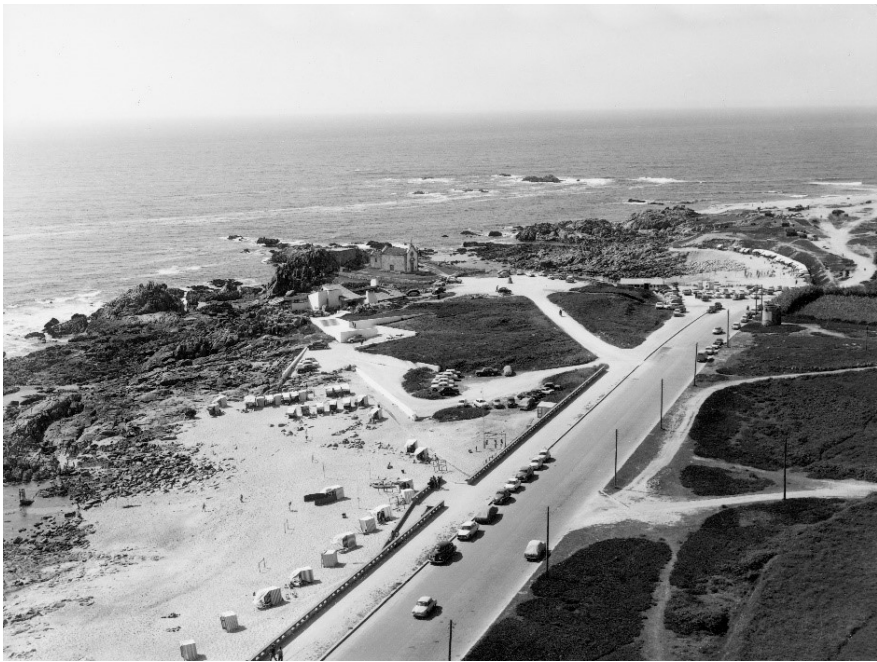
03. The site before the extension of the coastal avenue.

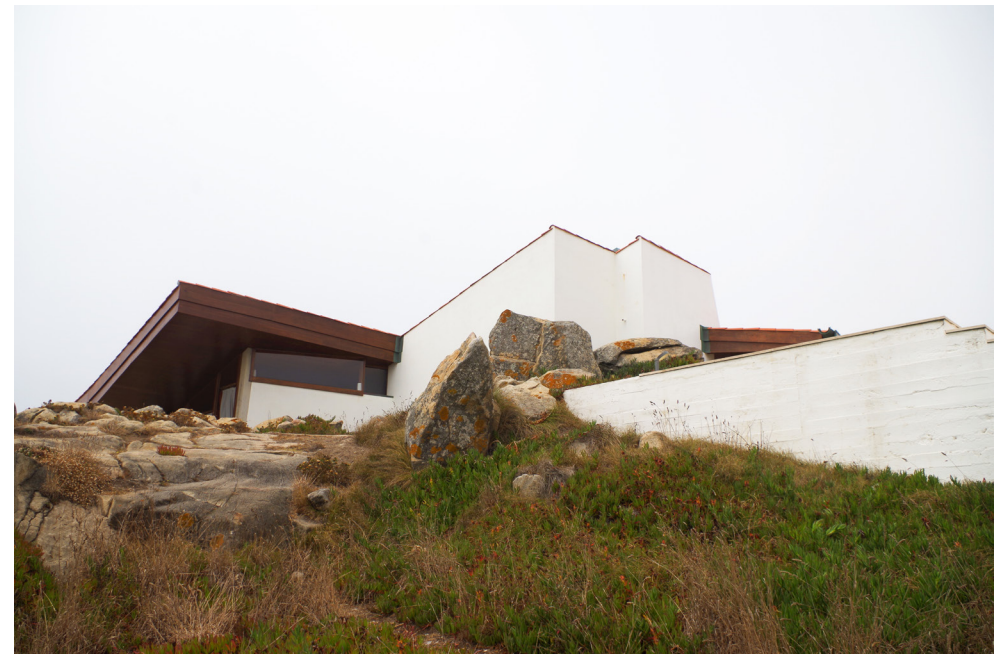
08. Detail of the east façade and of the tea room overhang.

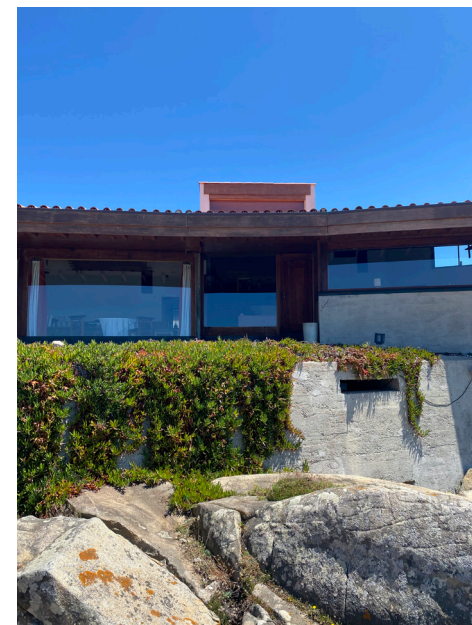
11. West façade detail.

Following the vertical structure, the exterior walls are constructed from 28 cm thick perpendicular masonry, resting directly on the rocky substrate or on cyclopean concrete foundation footings. On the west side, the façade consists of exposed reinforced concrete pillars supported by a cyclopean concrete retaining wall. This is paired with another wall of the same material to form a recess for the retractable windows of the room. All exterior walls are finished with plaster and painted on the outside.

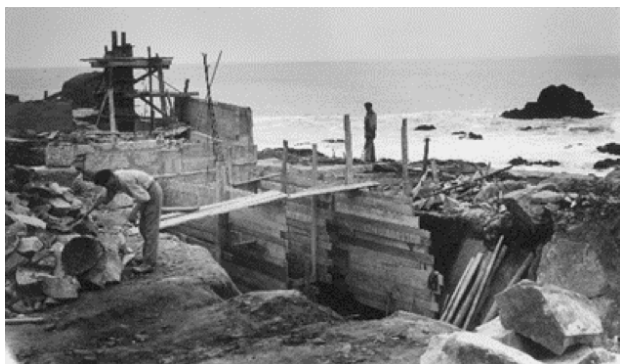
20. Laying of the foundations.

The vertical structure of the Boa Nova Tea House and Restaurant building comprises 28cm-thick granite walls and cyclopean concrete for retaining walls, along with reinforced concrete pillars (with an exposed finished) to support the roof structure. The horizontal structure consists of reinforced concrete beams supporting the roof slabs, which are made of 12 cm-thick cast ceramic elements with a 3cm compression layer.

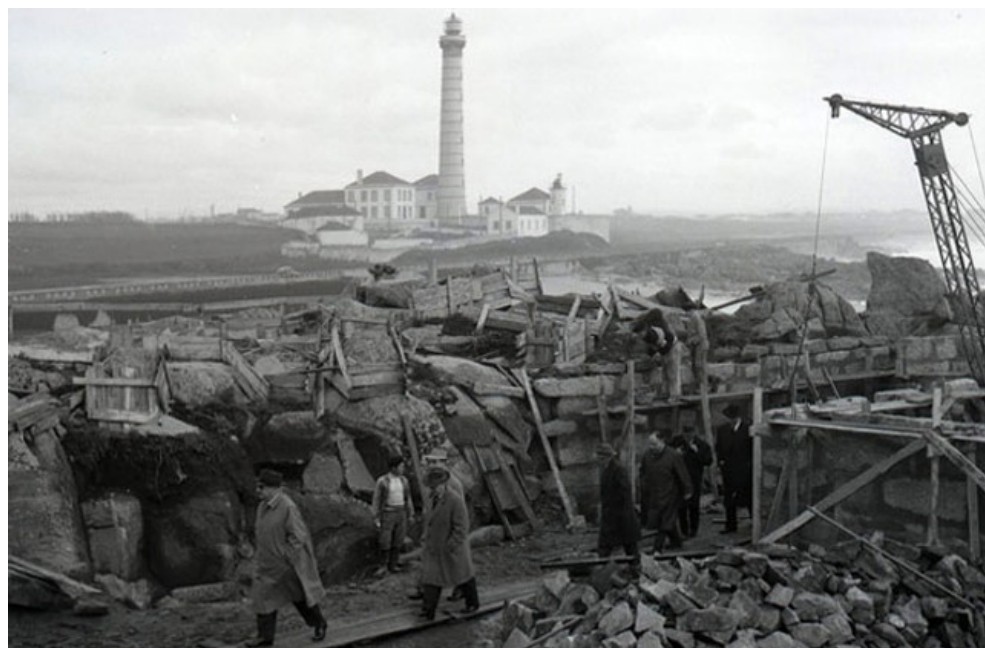
21. Construction of the perimeter walls.

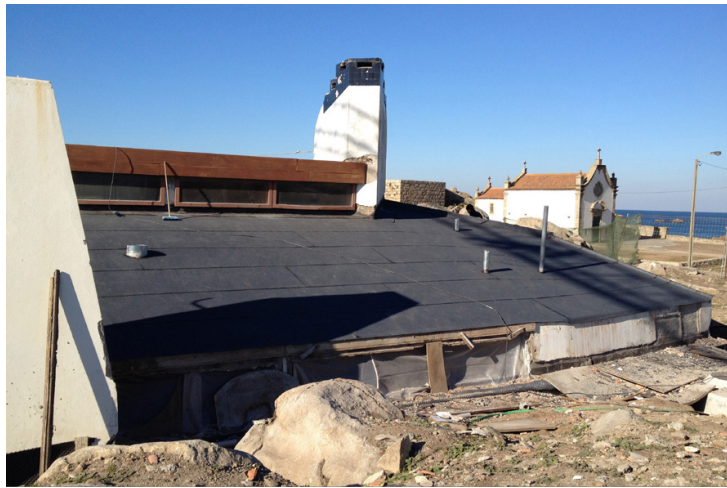
30. Replacement of the roof tiles and waterproofing membranes.

of furniture replicas, the localized repair of exposed concrete, the replacement of roof tiles and copper gutters by similar ones, the installation of air conditioning, the updating of technical spaces and the kitchen, and the electrification of the retractable window mechanism that allows the dining room to be completely open to the outside, creating continuity between the inside of the building and the surrounding landscape. Repairs on concrete followed a chromatic, texture, and formwork integration, finished with the application of a protective transparent coating.

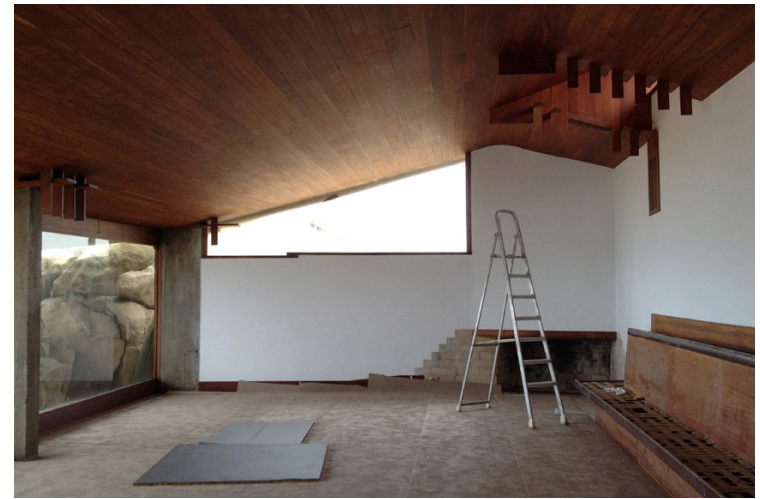
32. Conservation intervention on interior wood paneling.

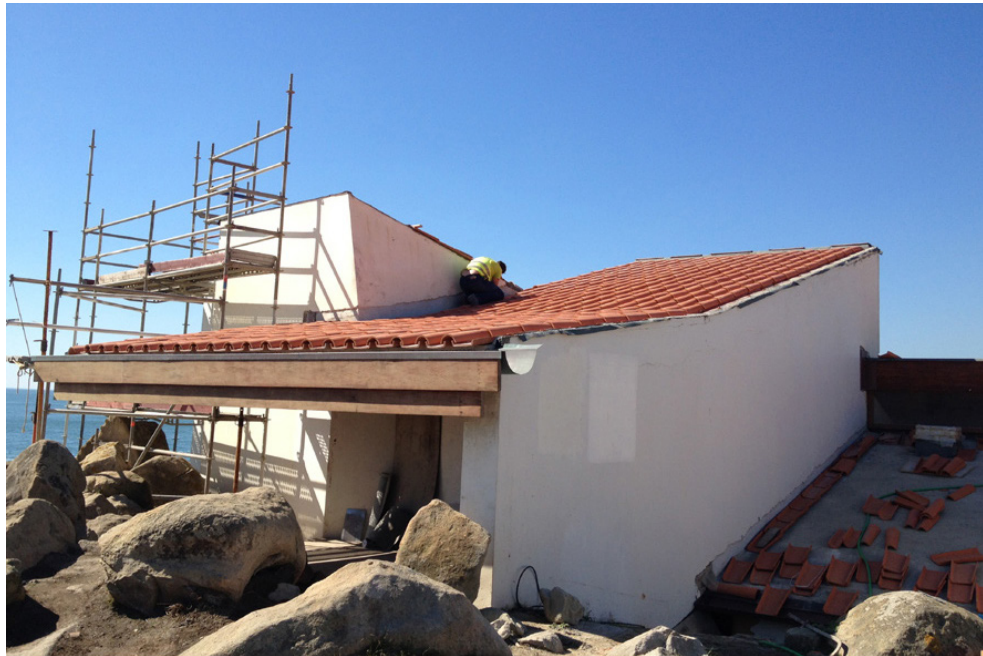
31. Replacement of the roof tiles.

The building's original materials have been well sustained thanks to their simple maintenance requirements and through conservation, as described in detail in Section 5. The roof tiles were completely replaced with shorter ones from a different company (as the original one was out of production), with special attention not to change roofs' character and movement. The copper gutters that have been altered and/or stolen were replicated with the help of existing documentation. The exposed concrete elements show small colour variations in the areas where their surface was repaired due to material spalling and rebar corrosion. Small artificial light sources were added in the grass along the building's access path.

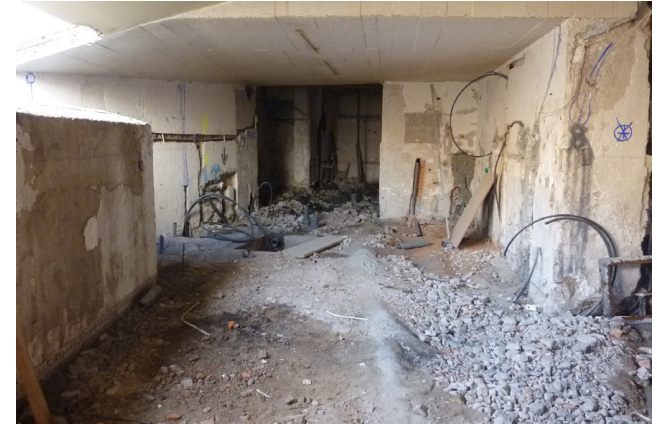
33. Kitchen renovation.

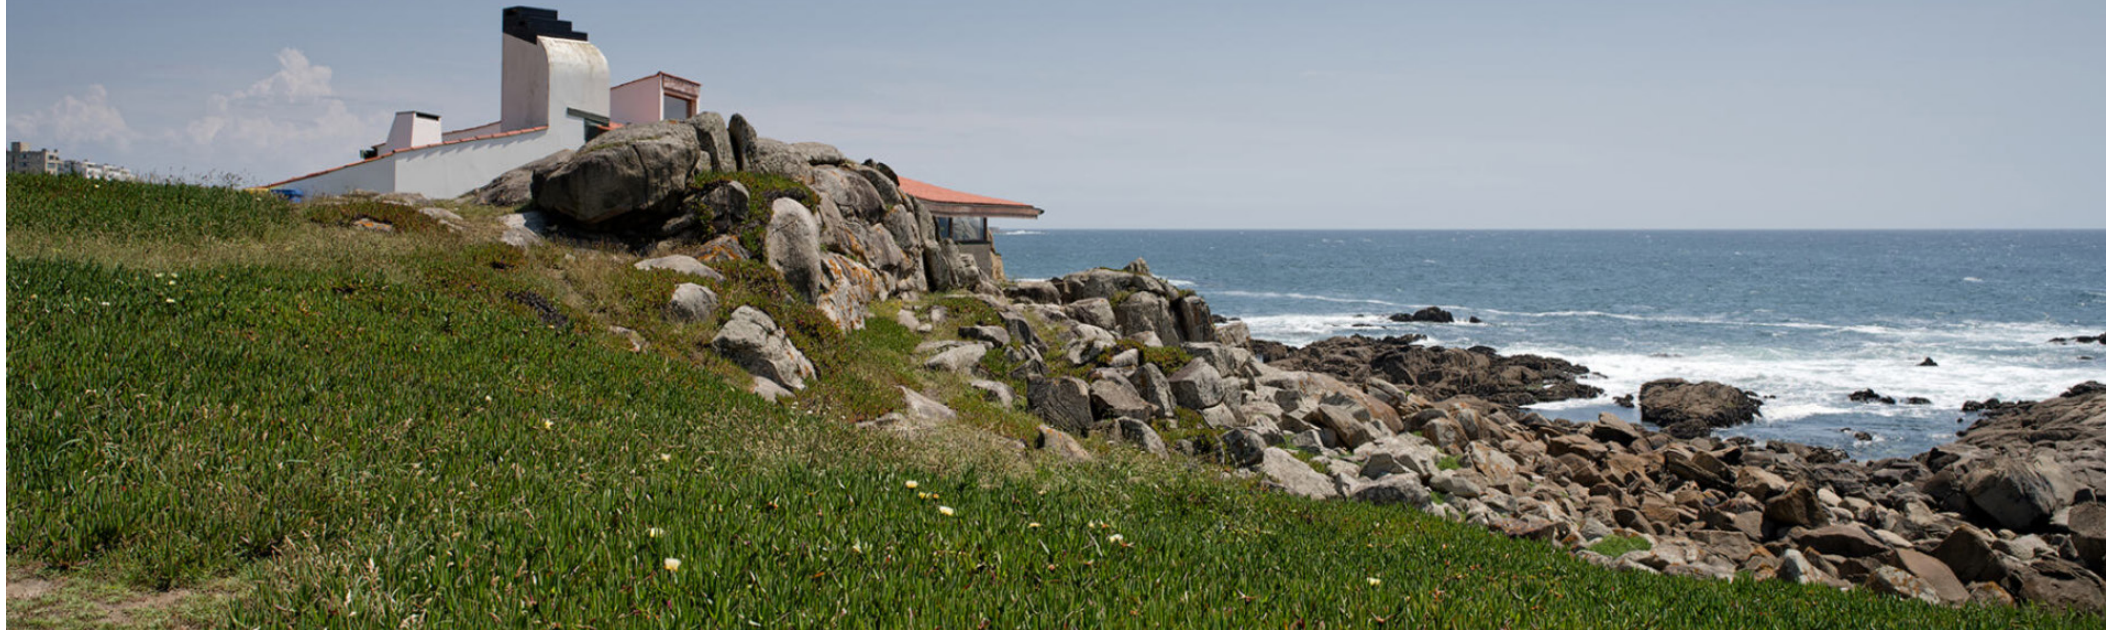
38. 360° Virtual Tour.

DIGITAL DOCUMENTATION results from an integrated methodology combining: i) photogrammetry; ii) 360° virtual tours (available through QR Codes); and iii) BIM didactic models. These techniques are adapted to each building with some limitations related with the photogrammetry conditions (vegetation, surface colours, and others) or to the access to the buildings, which was authorized in public buildings, and restricted in private houses and bank agencies.
